# ILLINOIS BUILDING INSPECTION, Inc.

## HOUSE INSPECTION REPORT

INSPECTION ADDRESS: \*\*\*\*\* Downers Grove, Illinois

DATE OF INSPECTION: January 6th, 2019

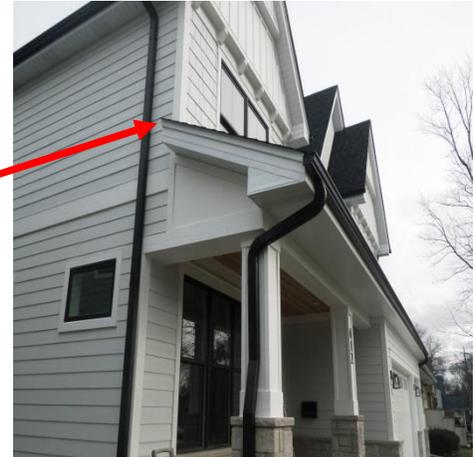
**Minor Repair** At the left side of the front porch, a roof section is missing edge-flashing, and a small portion of the OSB roof decking is exposed. Flashing should be installed here. See picture on next page.

This area of missing roof edge-flashing. . .

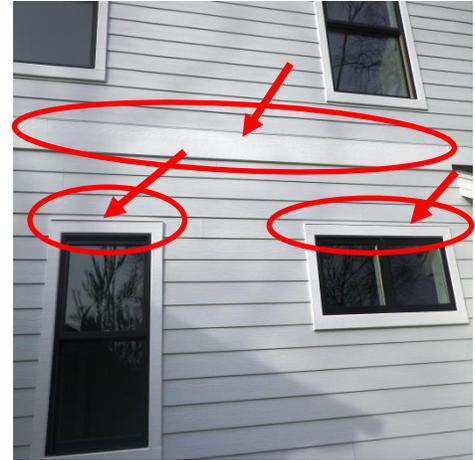
**Major Repair** The cement board siding on the house is not properly installed. The drip-cap flashings above the doors, the windows, the band-boards, and above all other wall penetrations should have a 1/4" gap above the flashing seats; the gaps should not be caulked—and they are. Also, the lower edges of the siding above the roof planes are too close to the roof; they should be 2" above the roof shingles, and they're not. And, in one area on the east side of the house, required kick-out flashing is missing. Plus, the lower edges of the wall siding should be 6" above finish soil grading, and they're not in several areas. Also, at one area on the east side of the house,

the end of the roof gutter should be 1" away from the siding, and it's not. These improper installations can promote both premature siding deterioration and water damage behind the siding. Related siding repairs and replacements should be made.

All of these are areas of flashing edges that should not be caulked (and there's plenty more such about the entire exterior)...

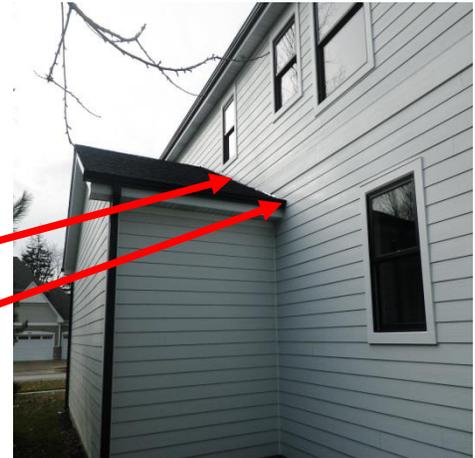
This one spot of a couple where the siding is too close to the roof. . .

This is where the kick-out flashing is missing, and, where the gutter end is too close to the siding. . .

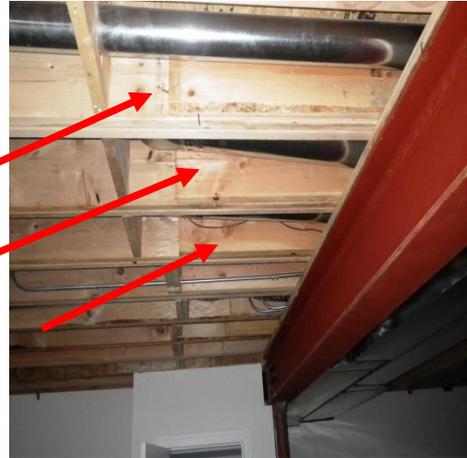
**FYI** There are several areas about the basement ceiling where the ceiling joists overhang the steel support beams by way too much. This will promote a joist \*teeter-totter\* effect; when a load is placed in the middle of the joist span, this will cause the end of the joist to lurch upwards. This can loosen flooring nails and other fasteners, leading at best to floor squeaks. A carpenter should alter or replace all such joists as needed. I don't know if this will be a Major Repair Item or a Minor Repair Item; it could go either way. Please consult with a Carpenter Contractor about what it will take and cost to address this. See picture on next page.

Like these too-long joist ends. . .

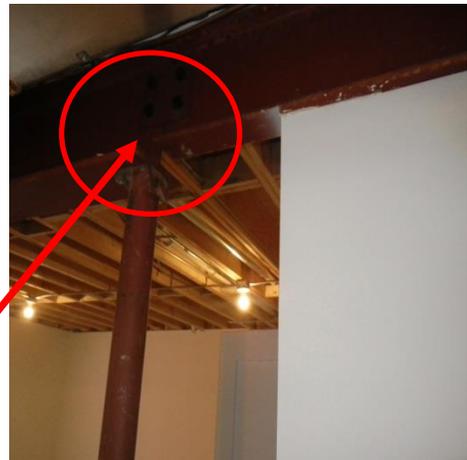
Here. . .

**Investigate Further** In the basement ceiling, just east of the basement stairwell, there is an atypical change in a steel beam size/height, and the two beam ends are oddly connected with a gusset and bolts. Normally, same size/height beam ends would meet and both would rest atop a steel support column. I've never seen such an atypical gusset & bolt joint, and I don't know if it's structurally sound. Have a structural engineer check this, and have related repairs or replacements made as/if warranted.

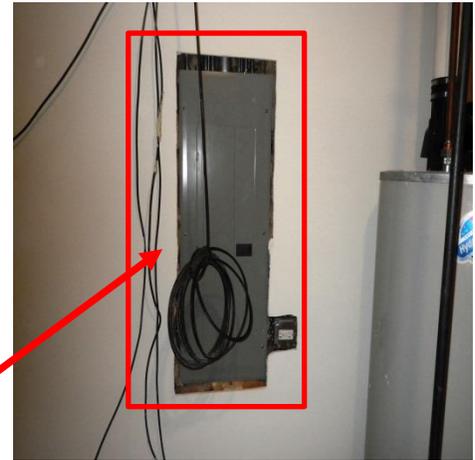
**Safety Concern/Investigate Further** There is a lack of adequate \*working room clearance\* around/in front of the main electrical panelboard. This makes taking the panelboard cover off awkward, and that poses a potential shock hazard. Adequate working room clearances should be attained by removing the drywall around the panelboard, and then the interior of the main electrical panelboard should be inspected.

This drywall. . .

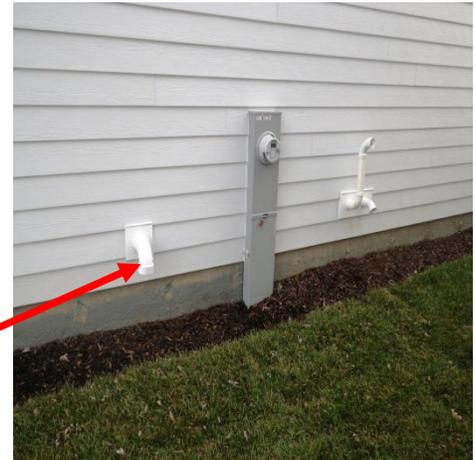
Here. . .

**Minor Repair** The exterior PVC flue pipe for the water heater is too close to the ground. Should the flue pipe be covered with snow, the water heater might not be able to start. The flue should be raised so it terminates at least 12" above any anticipated snowfall level.

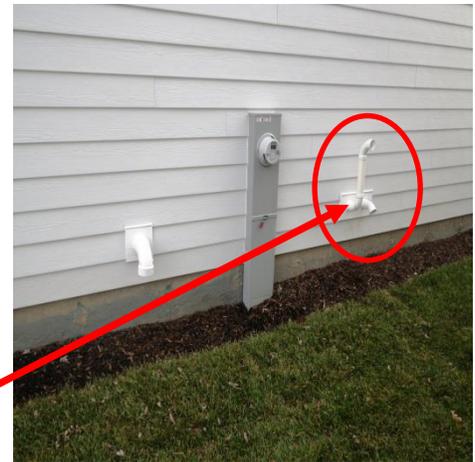
Here. . .

**Minor Repair** The exterior PVC furnace flue piping that serves the basement furnace terminates too close to the ground. Should this flue piping be covered with snow, the furnace may not be able to start (possibly leading to frozen and burst water supply pipes, which could result in catastrophic flood damage). The flue piping should be raised so it terminates at least 12" above any anticipated snowfall level.
