## HOUSE INSPECTION REPORT

INSPECTION ADDRESS: \*\*\*\*Pine Street Batavia, Illinois

DATE OF INSPECTION: November 15th, 2016

REPORTED YEAR BUILT: 1902

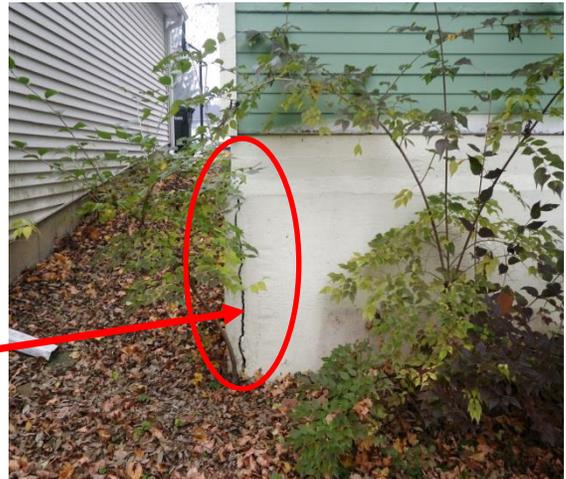
**FYI** There is a large crack in the foundation at the SW corner of the garage. If this foundation wall movement continues or worsens—*and only time will tell if it will*—costs to stabilize the foundation would make for a Major Repair.

Here. . .

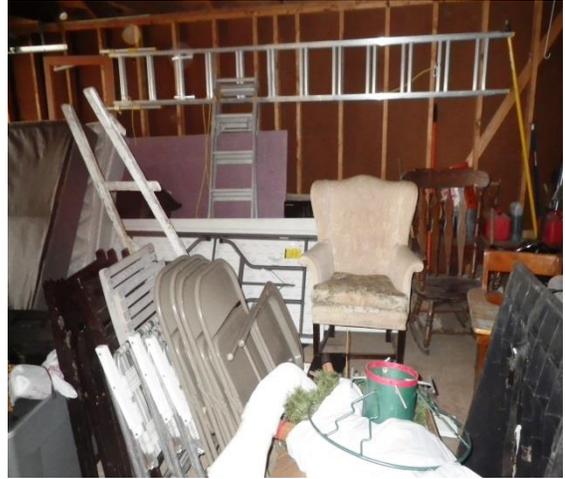
**Investigate Further** There was a lot of storage and clutter in the garage, greatly limiting what I could see. Once the garage is empty, it should be fully/properly inspected.

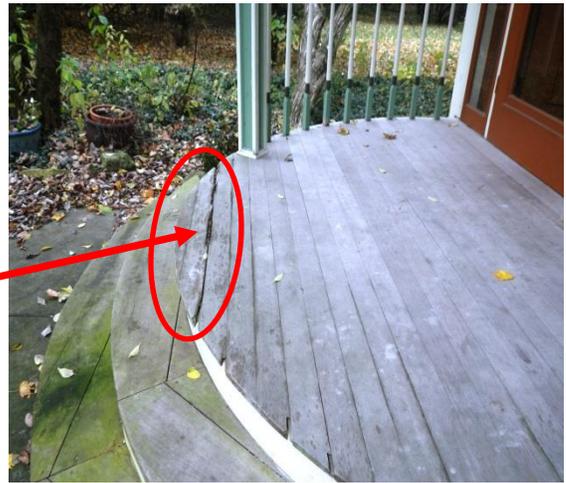
**Safety Concern** The loose and rotted outer floor board at the front porch poses a falling hazard. Have this board replaced A.S.A.P.

Here . . .

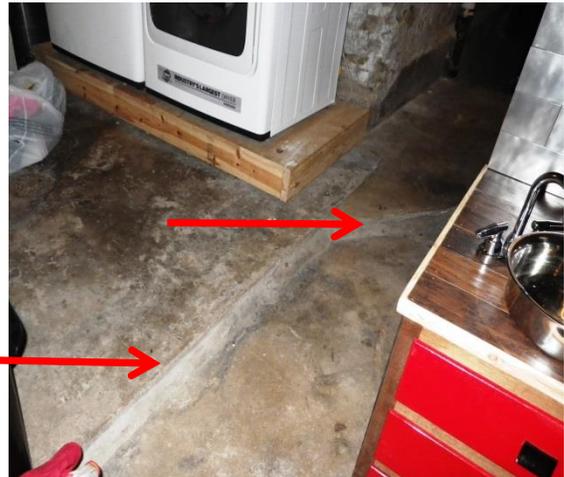
**Safety Concern** The short vertical offsets in the basement floor are not, at all, readily noticeable and as such pose stumbling/falling hazards. Have bright yellow \*warning\* stripes painted along these floor offsets.

Like in these areas. . .

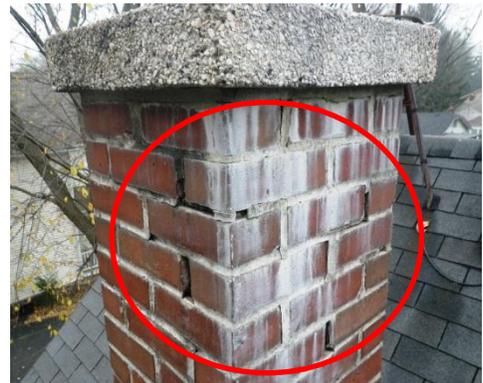
**Investigate Further** The masonry flue chimney that serves the furnace is highly deteriorated; much of the mortar is missing on this chimney. I don't know if this will be a Major Repair Item or a Minor Repair Item; it could go either way (it's a bit of a task to access and work on this rooftop chimney, and labor costs could add up). Please consult with a Masonry Contractor about what it will take and cost to address this. Like in these areas. . .

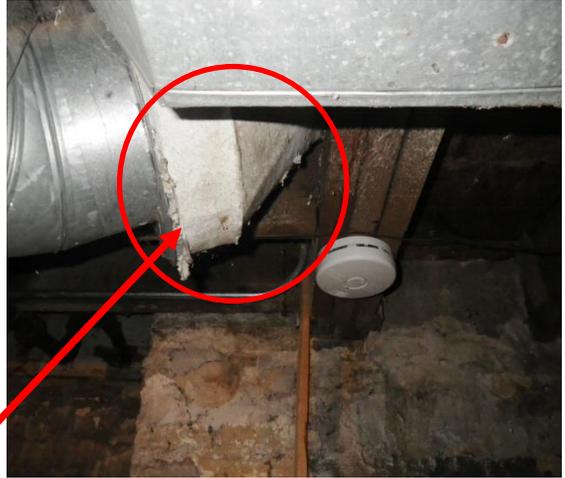
**Safety Concern** Some of the heating ducts in the basement ceiling are covered with apparent asbestos taping (*Chrysotile*). Asbestos can cause lung cancer. Asbestos fibers could have blown about the ductwork, into the furnace, and about the house. The taping should be tested for asbestos content. If the testing is positive for asbestos, dust samples from each level of the house and from inside the ductwork should be lab-tested for asbestos contamination. Asbestos mitigation should be performed as/if warranted by the testing results. You should note that costs for asbestos mitigation are typically significant.

Like this apparent Chrysotile. . .
